Fix My Laptop

Insurance Inspection Report.

Description of Current System:	Computer is a Samsung X10 notebook supplied with Chinese Windows XP Home. It seems to have been in good to average condition for its age. Original cost of this slimline unit was approx \$3500. It is a high-end laptop.
Manufacturer:	Samsung
Date of Production:	2003-4 approx.
Model Name:	X10
Specifications:	
Processor:	<input type="checkbox"/> AMD Sempron <input checked="" type="checkbox"/> Pentium Mobile 1.6Ghz <input type="checkbox"/> Centrino
Memory Fitted:	512mb of DDR RAM
Hard Drive Capacity:	40Gb 2.5" hard drives
Optical Device:	<input type="checkbox"/> CDROM _____ <input type="checkbox"/> CDRW _____ <input checked="" type="checkbox"/> CDRW DVD Combo_____ <input type="checkbox"/> DVD RW
Wireless:	<input checked="" type="checkbox"/> YES <input type="checkbox"/> NO
56K Internal Modem/ LAN :	<input checked="" type="checkbox"/> YES <input type="checkbox"/> NO
Screen Type and Size:	14" High Resolution LCD Damaged: <input type="checkbox"/> YES <input type="checkbox"/> NO <input checked="" type="checkbox"/> CAN'T SAY

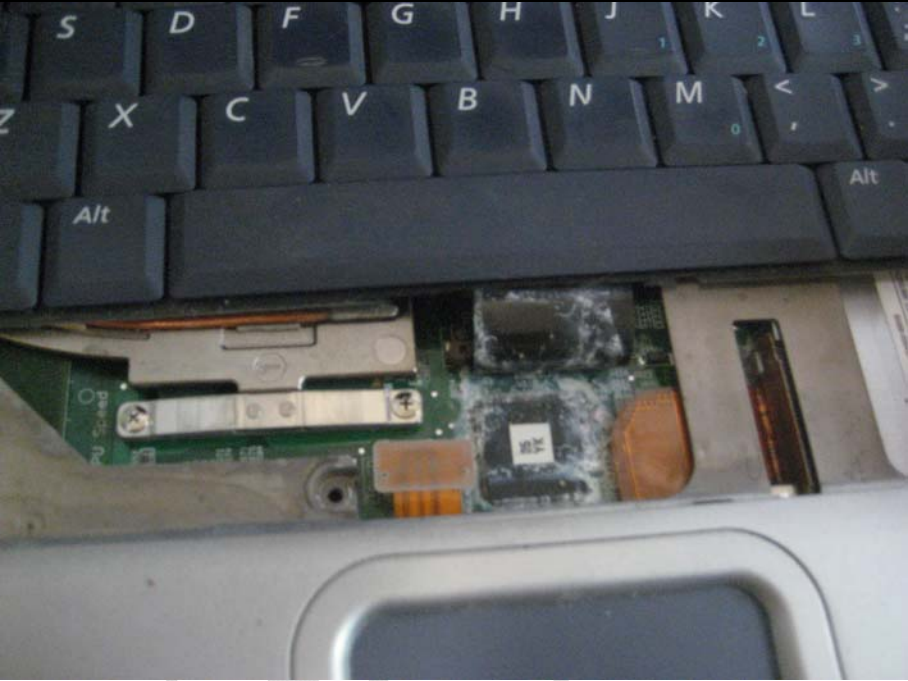
not quoted.
Photographic Evidence:

Was Laptop Physically Damaged?:	<input type="checkbox"/> Impact <input checked="" type="checkbox"/> Liquid. <input type="checkbox"/> Other
Describe Signs of Physical Damage:	<input type="checkbox"/> Broken Casing <input checked="" type="checkbox"/> Water Stains <input type="checkbox"/> Broken Hinges <input checked="" type="checkbox"/> Ports damaged at Rear (dc jack) <input type="checkbox"/> Damaged Keyboard (water) <input type="checkbox"/> Burnt Circuit Board(s) <input checked="" type="checkbox"/> Corroded Circuit Board(s) <input type="checkbox"/> Damaged Power Pack <input type="checkbox"/> Other - See below.
Was the Laptop disassembled and Tested?:	<input type="checkbox"/> YES <input checked="" type="checkbox"/> NO
Individual Component Report:	<i>(Items are Removed and Tested on Bench as far as is practicable)</i>
CPU:	Tested: <input type="checkbox"/> YES <input checked="" type="checkbox"/> IO - <input type="checkbox"/> PASS <input checked="" type="checkbox"/> FAIL Unit would not boot up and attempts to get it working are utterly futile.

Memory:	Tested: <input type="checkbox"/> YES <input checked="" type="checkbox"/> NO - <input type="checkbox"/> PASS <input checked="" type="checkbox"/> FAIL Visible corrosion
Hard Drive:	Tested: <input checked="" type="checkbox"/> YES <input type="checkbox"/> NO - <input type="checkbox"/> PASS <input checked="" type="checkbox"/> FAIL Removed and tested. Dead. Visible corrosion.
Optical Drive:	Tested: <input type="checkbox"/> YES <input checked="" type="checkbox"/> NO - <input type="checkbox"/> PASS <input type="checkbox"/> FAIL
Floppy Drive:	Tested: <input type="checkbox"/> YES <input type="checkbox"/> NO - <input type="checkbox"/> PASS <input type="checkbox"/> FAIL
Modem / LAN:	Tested: <input type="checkbox"/> YES <input checked="" type="checkbox"/> NO - <input type="checkbox"/> PASS <input type="checkbox"/> FAIL
Power Pack:	Tested: <input type="checkbox"/> YES <input checked="" type="checkbox"/> NO - <input type="checkbox"/> PASS <input type="checkbox"/> FAIL

Stated Insurance Event:	The customer advised that the unit was damaged when a pot plant was overfilled with water and the laptop was flooded with a large volume of water.
Conclusion:	From the inspection we concluded that the damage is consistent with the stated "Insurance Event" <input checked="" type="checkbox"/> YES <input type="checkbox"/> NO <input type="checkbox"/> N/A
Findings:	We have inspected the unit and found damage to these components: <ul style="list-style-type: none"> - motherboard - Keyboard - RAM - Hard Drive <p>This damage is all consistent with a water damage.</p>
Recommendation:	We recommend the unit not be repaired . The damage is too extensive.
Quotation to Replace:	My understanding is the customer, due to urgent business needs, has already replaced the laptop. We therefore have
